# Manhole Inspection Summary

Manhole # S23CC1037MH

Insp Date: **1/30/07 12:49 PM**

**Location** Address: **1434 DELLWOOD AVE**

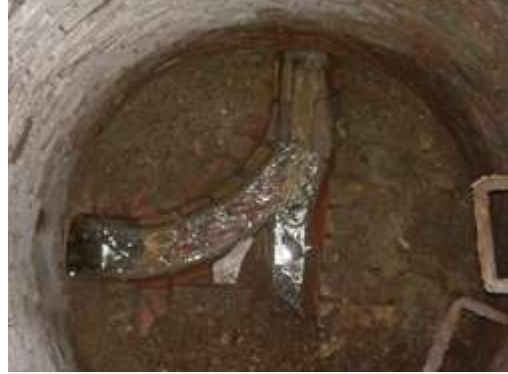
Top View

Corroded and missing steps. Evidence of surcharge - Bench debris. Channel debris.

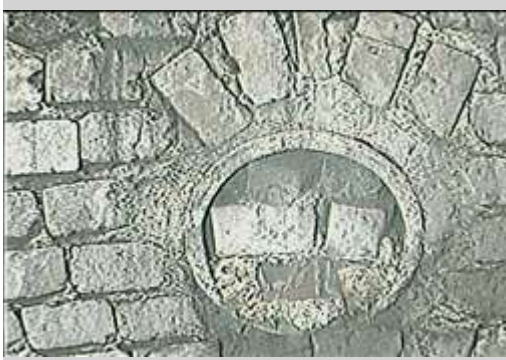
Abandoned I6 pipe

Abandoned I6 pipe. Barrel deterioration and infiltration.

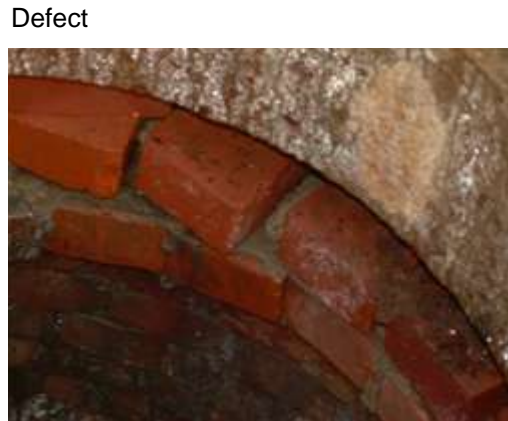
Defect

Frame leaks. Adjustment deterioration, loose brick and infiltration.

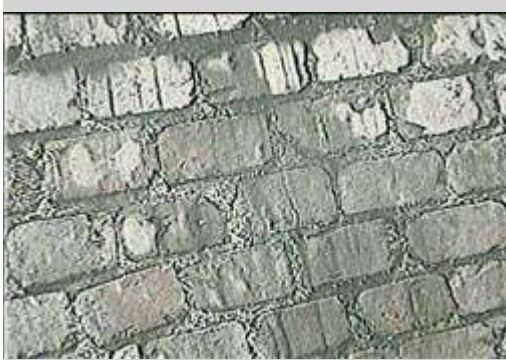
Defect

Barrel deterioration and infiltration.

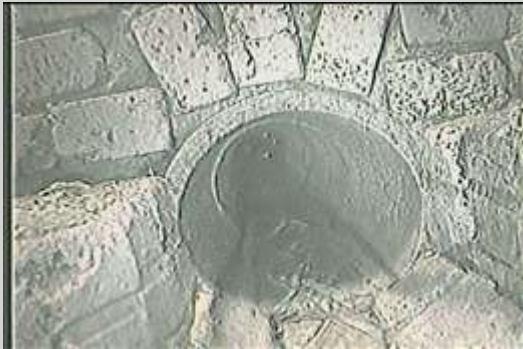
### 8 in. Circular Gravity Sewer Pipe Out @ 12 O'Clock

Infiltration: **Evidence** Pipe Seal Cond: **Broken**

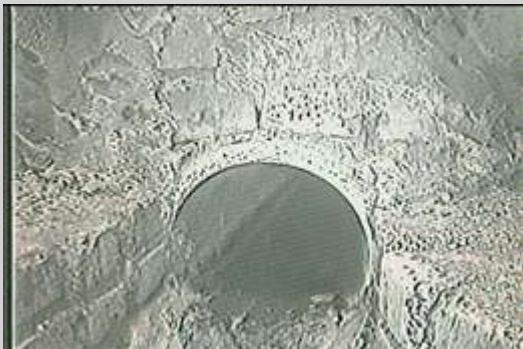
### 8 in. Circular Gravity Sewer Pipe In @ 9 O'Clock

Deposits: ☐ None ☒ **Mud** ☐ Sludge ☒ **Debris** ☐ Grease

Silt Depth: **0** (in.) Deposits Extent: **Light**
